NAUGATUCK RIVER BASIN
WATERTOWN, CONNECTICUT

ECHO LAKE DAM
CT 00124

PHASE I INSPECTION REPORT
NATIONAL DAM INSPECTION PROGRAM

JUNE 1980

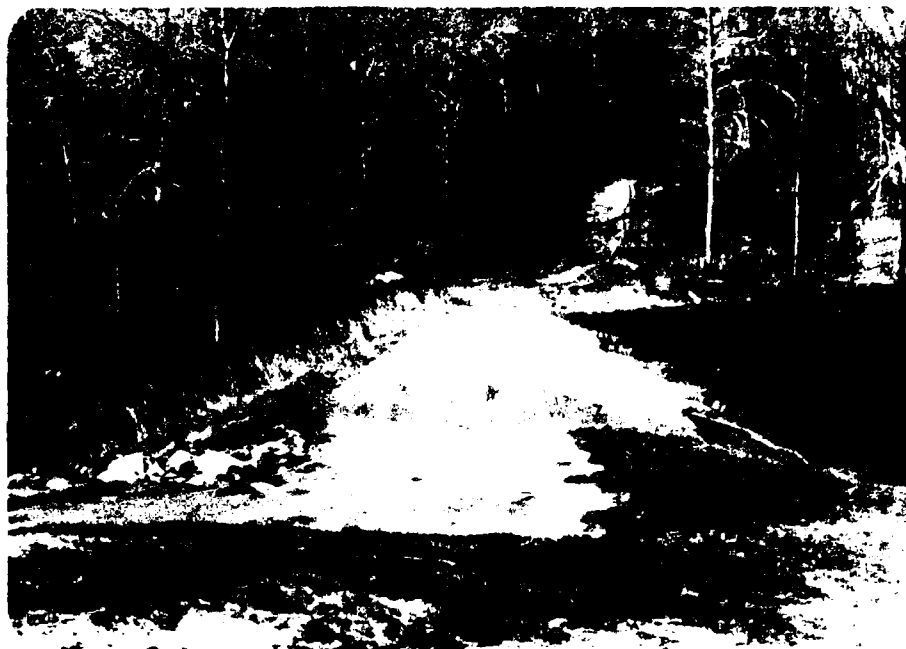
PHOTO NO. 1

The emergency spillway consists of a broad crested weir constructed of bituminous concrete, Photo 1. The bituminous concrete has been extensively cracked and eroded along the downstream slope,

DAM FROM LEFT ABUTMENT

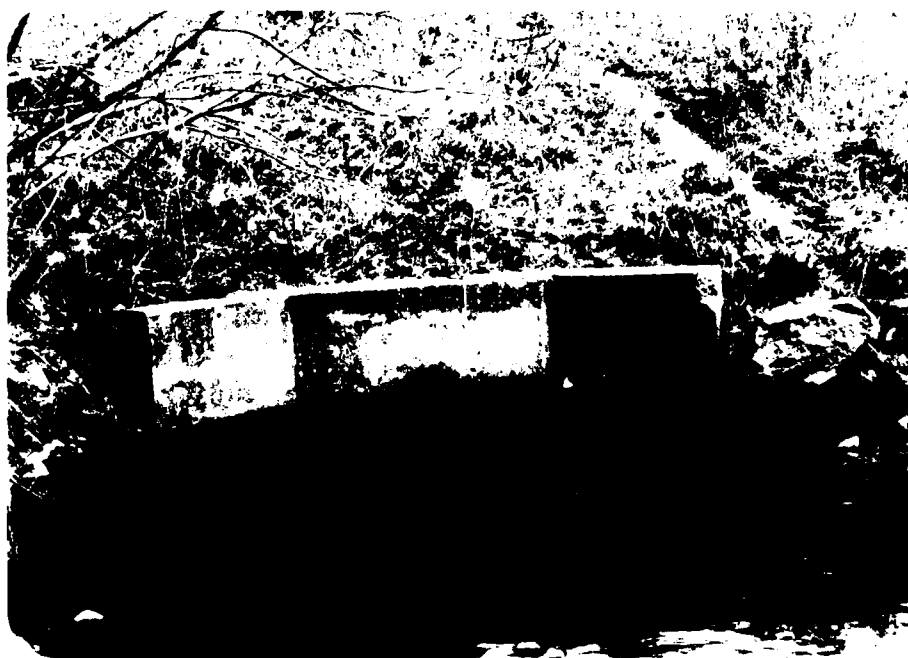
PHOTO NO. 4

concrete endwall for the outlet pipe, Photo 4. A small hole, approximately 7 inches in diameter and 12 inches deep, was observed just upstream of the concrete endwall, Photo 5. Seepage was observed exiting from the toe of the downstream slope near the right end of the concrete endwall, Photo 6. The area was rust-colored and flow was free of sediments at the time of inspection.

CONCRETE ENDWALL AT OUTLET OF 24-INCH RCP.
NOTE SLUMPING AT ENDS OF WALL.

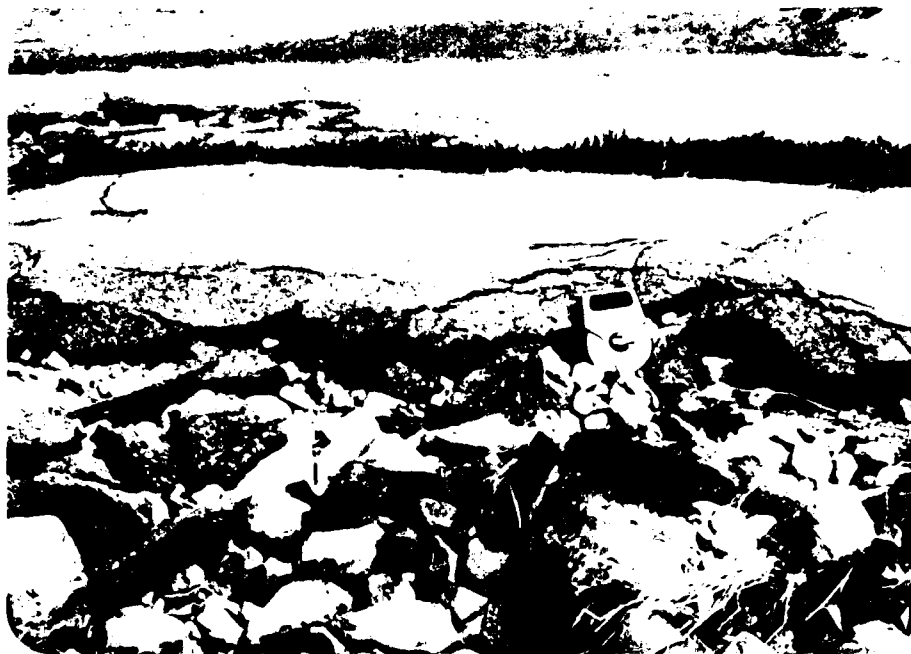
PHOTO NO. 9

5. The deterioration of the auxiliary spillway channel downstream of the dam could eventually cause a breach of the dam.

BITUMINOUS CONCRETE OF
AUXILIARY SPILLWAY

5. The deterioration along the downstream channel of the auxiliary spillway should be investigated and remedial measures to prevent the undermining of the spillway slab should be designed and constructed.

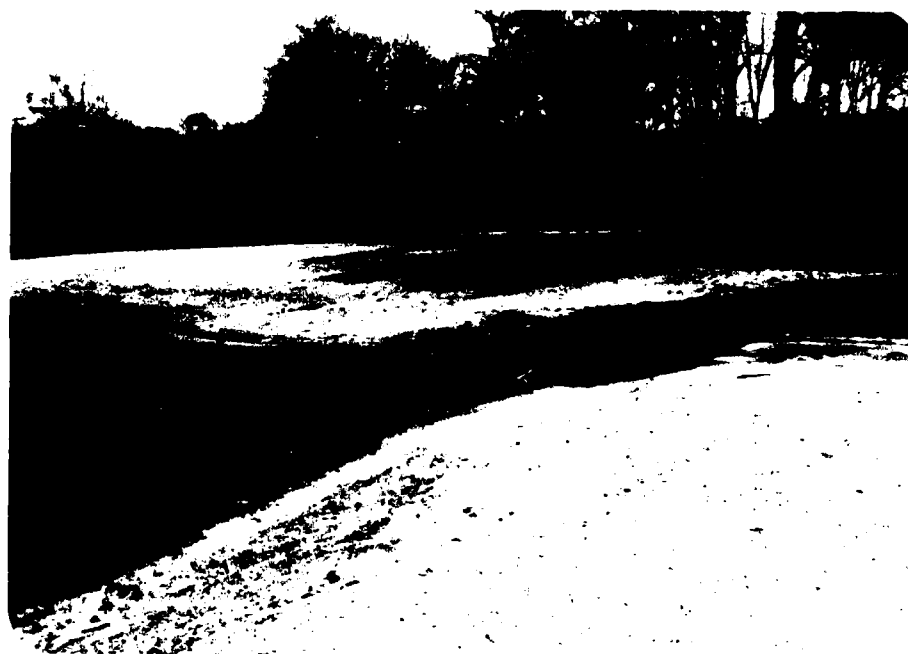
PHOTO NO. 10

It appears that a portion of the beach has encroached on the upstream side of the auxiliary spillway, Photo 10. No other indications of instability along the edges of the reservoir in the vicinity of the dam were noted.

BEACH UPSTREAM OF AUXILIARY SPILLWAY
APPEARS TO OBSTRUCT FLOW
